**DEPARTMENT OF TRANSPORTATION**

Contract #: 04-0120F4Cty: SF/ALA Rte: 80 PM: 13.2/13.9File #: 1.28**WELDING INSPECTION REPORT****Resident Engineer:** Casey, William**Address:** 333 Burma Road**City:** Oakland, CA 94607**Report No:** WIR-029096**Date Inspected:** 07-Feb-2013**Project Name:** SAS Superstructure**OSM Arrival Time:** 700**Prime Contractor:** American Bridge/Fluor Enterprises, a JV**OSM Departure Time:** 1730**Contractor:** American Bridge/Fluor Enterprises, a JV**Location:** Job Site**CWI Name:** See below.**CWI Present:** Yes No**Inspected CWI report:** Yes No N/A**Rod Oven in Use:** Yes No N/A**Electrode to specification:** Yes No N/A**Weld Procedures Followed:** Yes No N/A**Qualified Welders:** Yes No N/A**Verified Joint Fit-up:** Yes No N/A**Approved Drawings:** Yes No N/A**Approved WPS:** Yes No N/A**Delayed / Cancelled:** Yes No N/A**Bridge No:** 34-0006**Component:** Tower**Summary of Items Observed:**

## WELDING INSPECTION REPORT

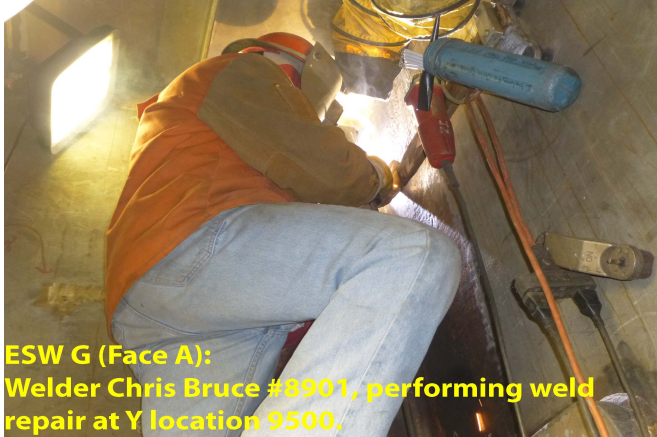
The welder was observed Carbon Arc Gouging (CAG) and performing the weld repairs on excavations on the Electroslag Weld "G" S-045 at face A. The indication was rejected with Ultrasonic Testing Shear Wave and was excavated at Y location 9500 as per Request for Weld Repair (RWR) 201301-055. The welder was observed preheating the weld to 300 degrees Fahrenheit prior to welding using the Miller ProHeat 35 with heat induction blankets. The welder utilized the Welding Procedure Specification (WPS) ABF-WPS-D15-1000-Repair Rev.3 for Shield Metal Arc Welding (SMAW). The welding parameters were verified by QC Inspector William Sherwood throughout the day and they appeared to be in compliance with the WPS noted above.

**ESW G (Face A):**  
**Welder Chris Bruce #8901, performing weld**  
**repair at Y location 9500.**

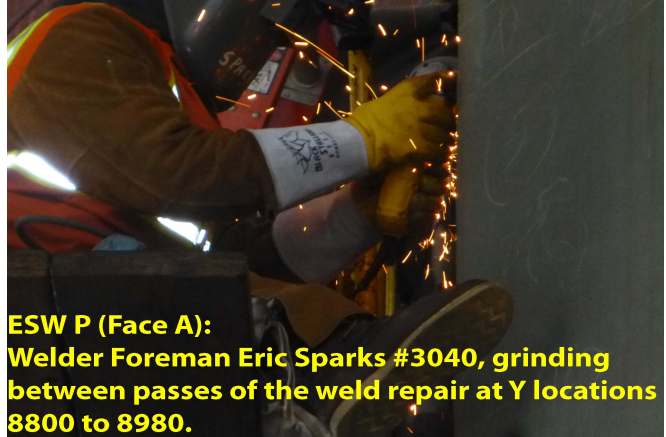
The welder was observed continuing the weld repair on the Electroslag Weld "P" N-043 at face A, at the combined Y locations 8800, 8830, 8890 and 8980 as per Request for Weld Repair (RWR) 201301-051. The welder was observed preheating the weld to 300 degrees Fahrenheit prior to welding using the Miller ProHeat 35 with heat induction blankets. The welder utilized the Welding Procedure Specification (WPS) ABF-WPS-D15-1000-Repair Rev.3 for Shield Metal Arc Welding (SMAW). The welding parameters were verified by QC Inspector William Sherwood throughout the day and they appeared to be in compliance with the WPS noted above.

**ESW P (Face A):**  
**Welder Foreman Eric Sparks #3040, grinding**  
**between passes of the weld repair at Y locations**  
**8800 to 8980.**
